In the first of a trilogy looking at key safety aspects of modern yachts, Barry Deakin from Southampton's Wolfson Unit for Marine Technology and Industrial Aerodynamics reports on the 1992 Japan-Guam Race and the Japanese research that has resulted

# japan-guam race tragedy

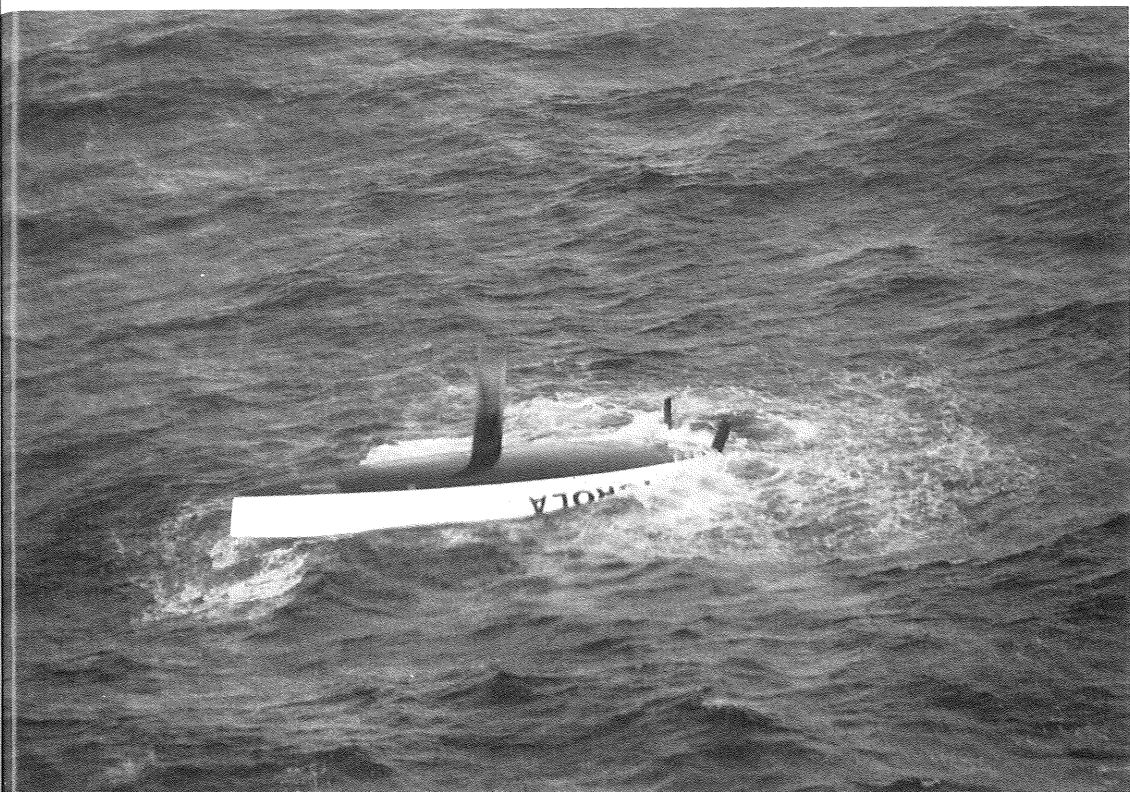
**P. 15: Mike Plant's Coyote – a recent victim of bulb detachment. Top: Martela OF after keel failure, Whitbread 89/90. Above: Martela's keel already straining after leg 1. Right: Fleury Michon – three days into the Vendée Globe**

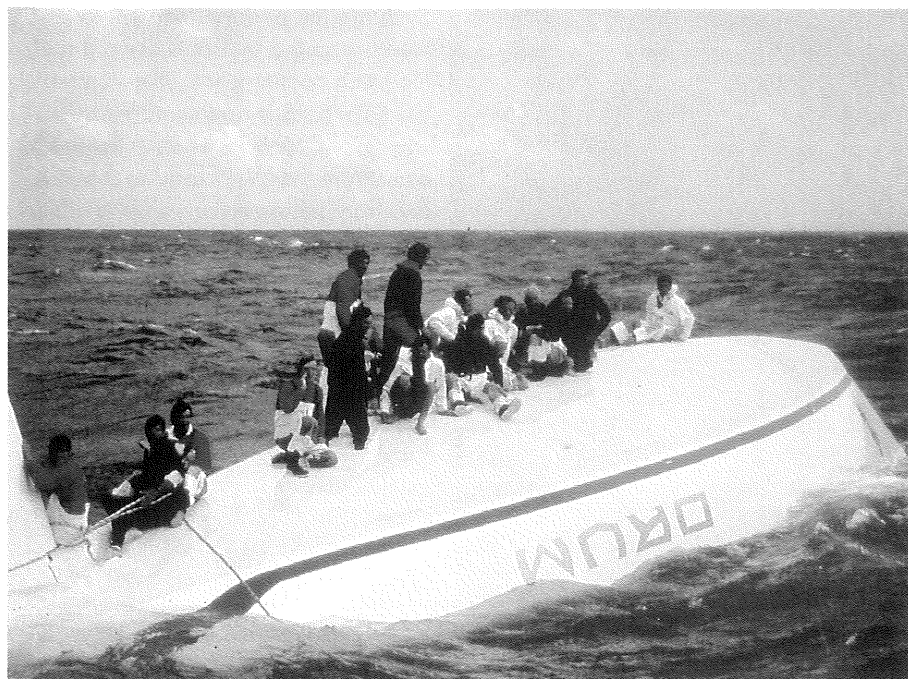
**Drum's keel failure during the 1985 Fastnet – like Martela's mishap – could easily have had more tragic consequences**
