# Evaluating Effectiveness of Adaptive Measures against Storm Surge Hazard based on Field Experience from a Real Time Cyclone in Bangladesh Coast

## ABSTRACT

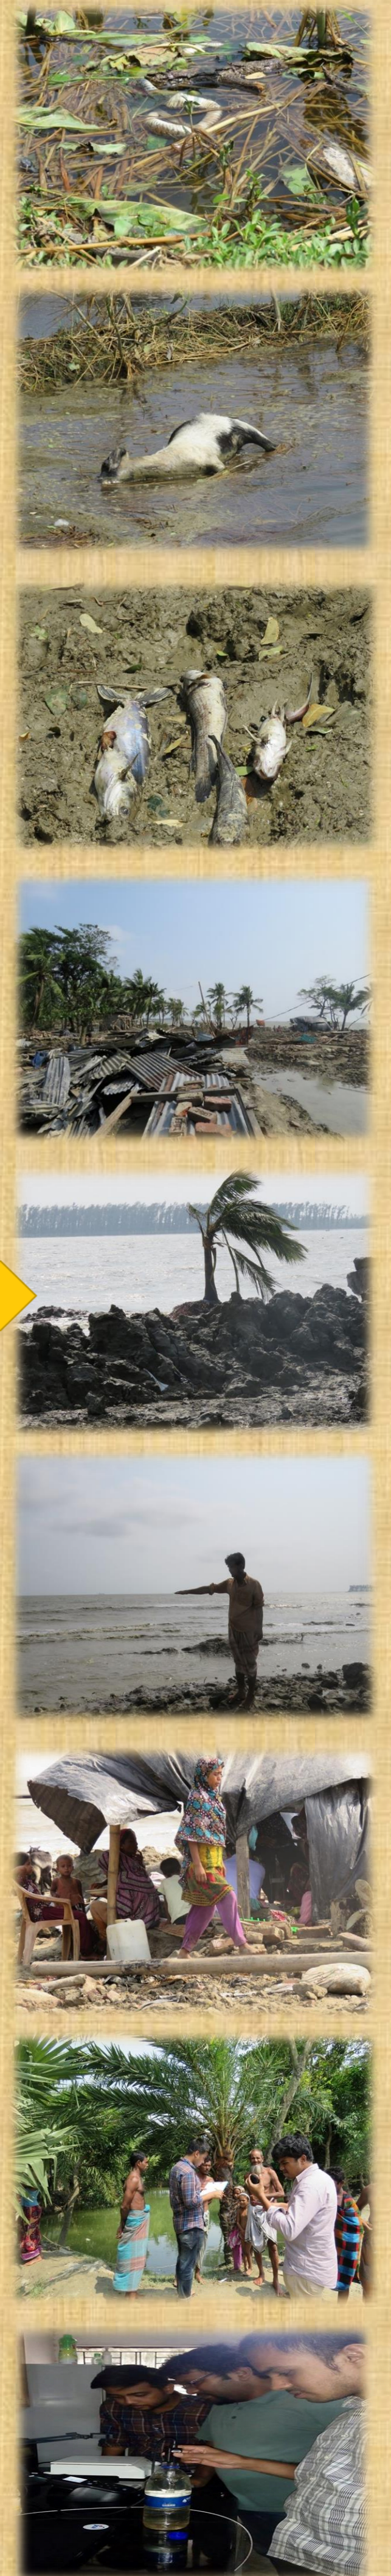
### FIELD VISIT

- Polders at Bashkhali were washed away resulting inundation of large area.
- Around 15 km landward limit of Bashkhali area was inundated resulting widespread destruction.

- Inundation was mainly due to polder overtopping and breaching.
- Cyclone warning system was found to be inaccurate and 'difficult to understand' to the local people and thus found to be useless.
